Subject: Annual Inspection Report
Haleyville Municipal (Posey Field) Airport

ANNUAL INSPECTION REPORT

HALEYVILLE MUNICIPAL (POSEY FIELD) AIRPORT

HALEYVILLE, ALABAMA

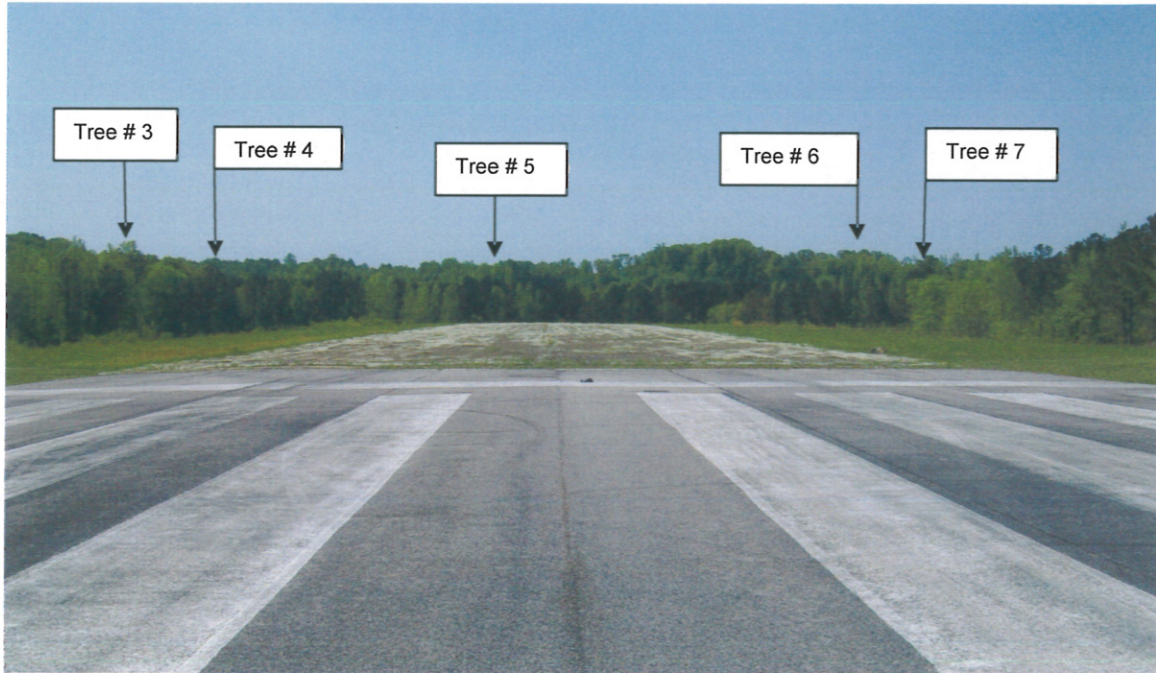
- Runway 36: The approach and departure path for runway 36 was inspected and found to meet state licensing standards. However, trees identified as Tree # 3 , # 6 and # 7 violate the 20:1 approach slope within limits of the FAA's Runway Protection Zone (RPZ) and a tree identified as Tree # 4 AND # 5, if allowed to continue to grow will eventually penetrate the ALDOT 20:1 Approach/Departure Path (See Photo # 1, and Appendix 2).
- Runway 18: No obstructions (See Photo # 2 and Appendix 3)

Photo # 1 – Runway 36 RPZ Obstructions and Potential Obstructions

- While the airport meets the state requirements, the violations to the 20:1 FAA approach slope within the limits of the RPZ for runway 36, as depicted on the most recent Airport Layout Drawing (ALD) dated August 2002 should be removed as well as the potential obstructions, before they become hazards.

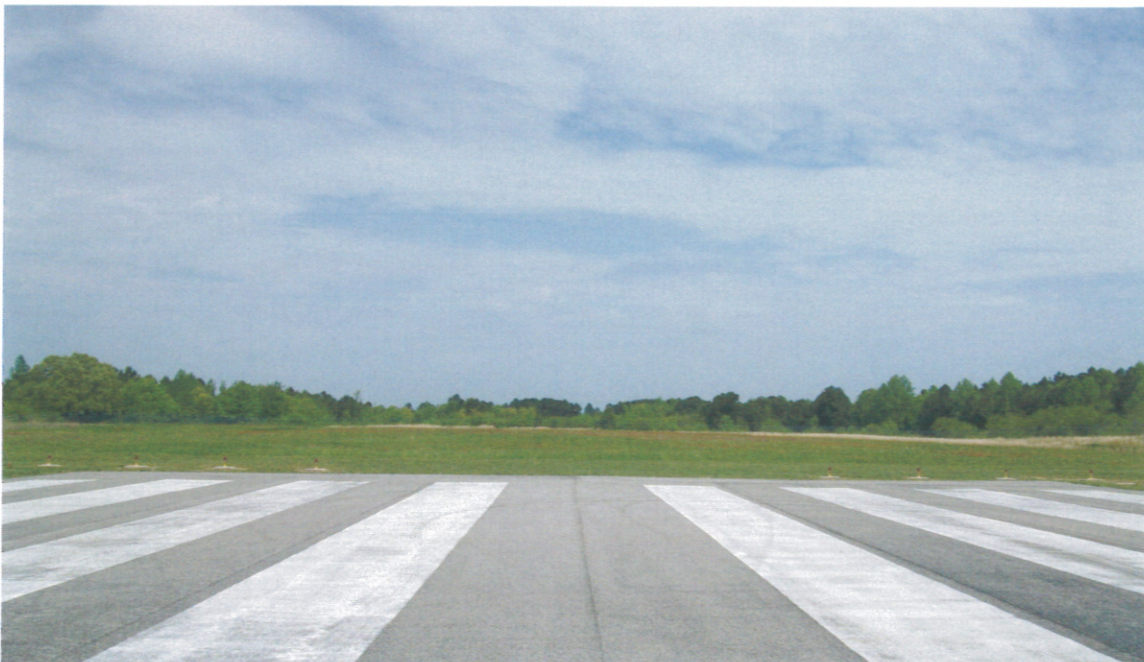
Photo # 2 – Runway 18 Approach

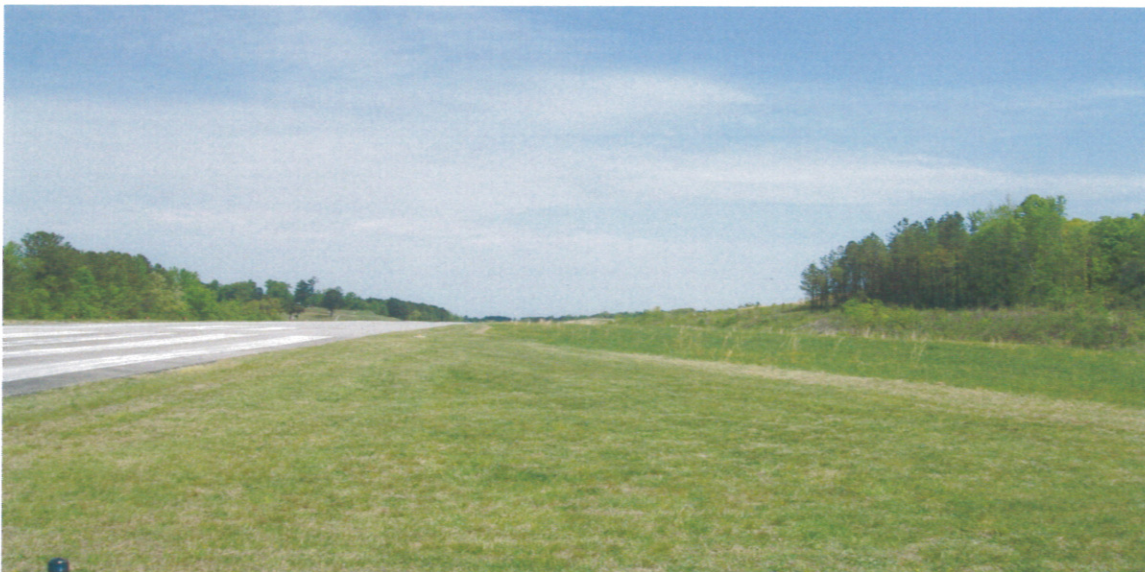
- The primary surface meets state safety requirements (See Photo # 5).

Photo # 3 - Primary Surface

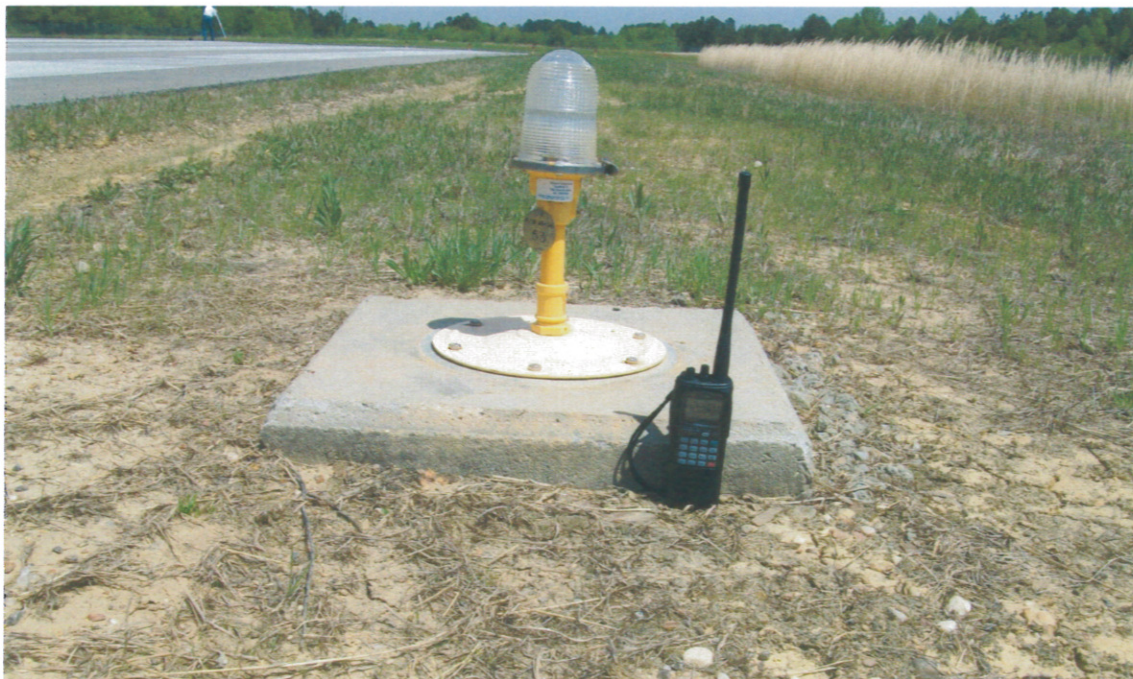
- The grade of the runway safety area meets state safety requirements; however, there has been erosion around runway light bases (See Photo # 4).

Photo # 4 – Runway Light Erosion

The grade around some of the runway lights is beginning to erode exposing the concrete bases, as described in section 3 above.

- These areas should be compacted and graded smooth with no ruts, humps, depressions or other potentially hazardous surface variations.

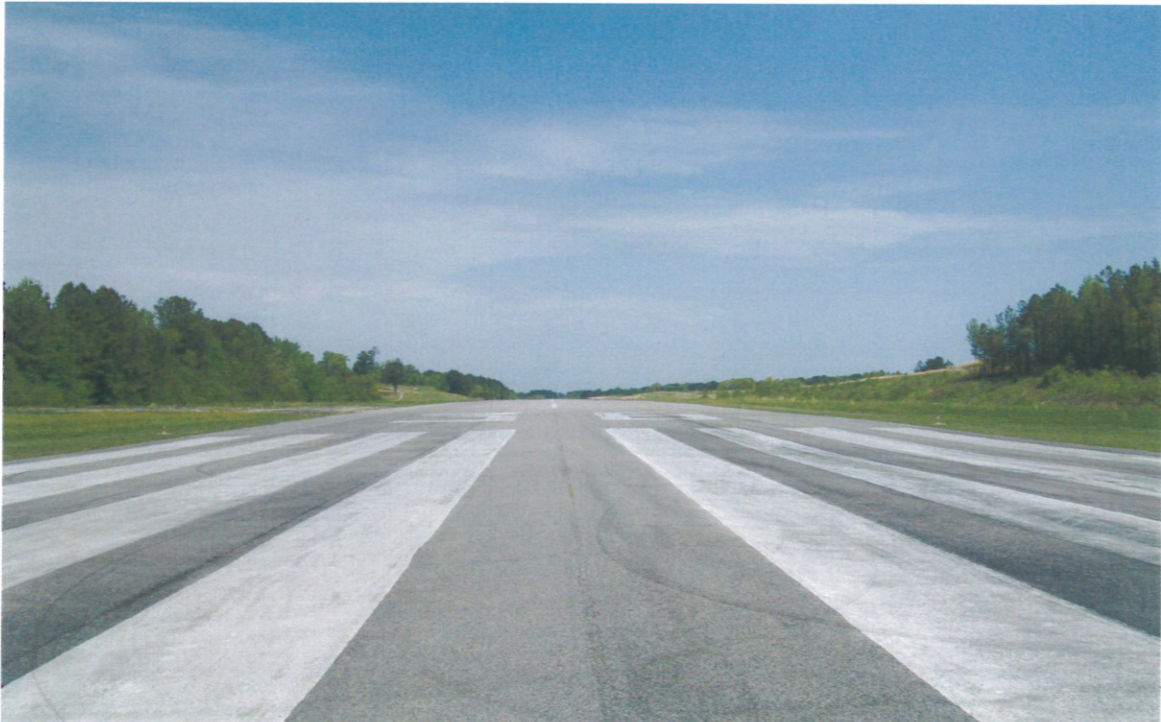
- The airport markings are in fair to good condition (See Photo # 5).

Photo # 5 - NPI Markings RWY 36

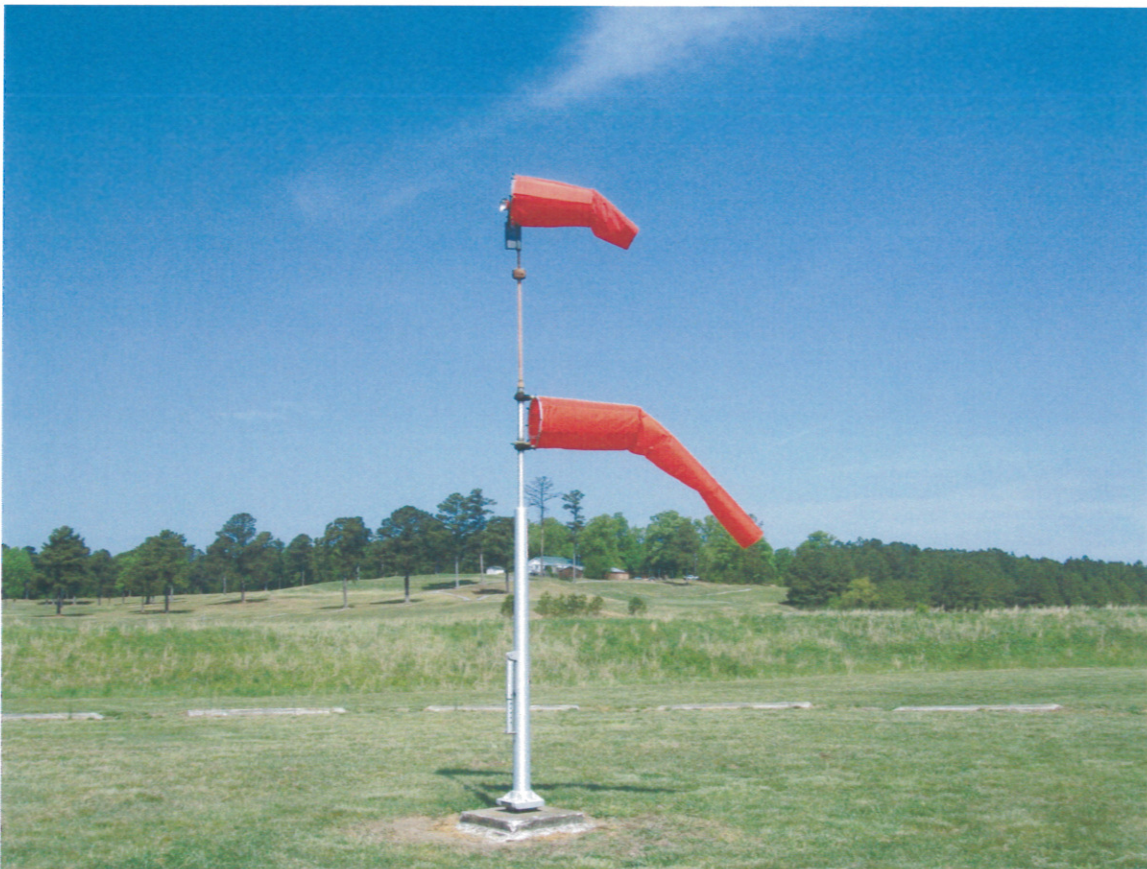
- The wind cone was found to meet state licensing standards (See Photo # 6).

Photo # 6 – Wind Cone

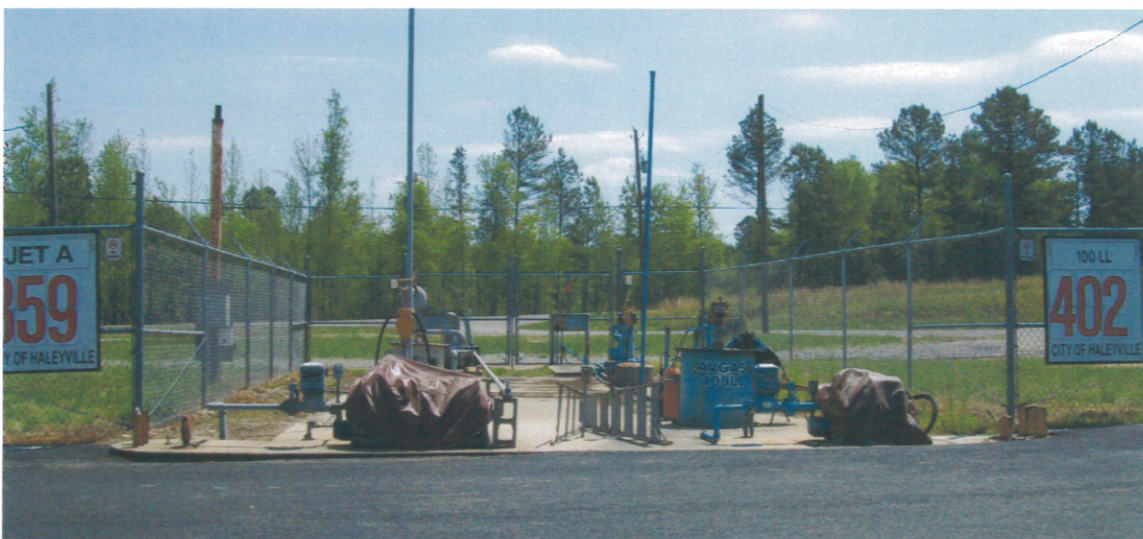
- The fueling area meets the requirements established by the Alabama Department of Transportation. However, the State of Alabama Department of Agriculture and Industries may have additional requirements for fueling systems that were not considered during this inspection (See Photo # 7).

Photo # 7 – Fuel Service Area

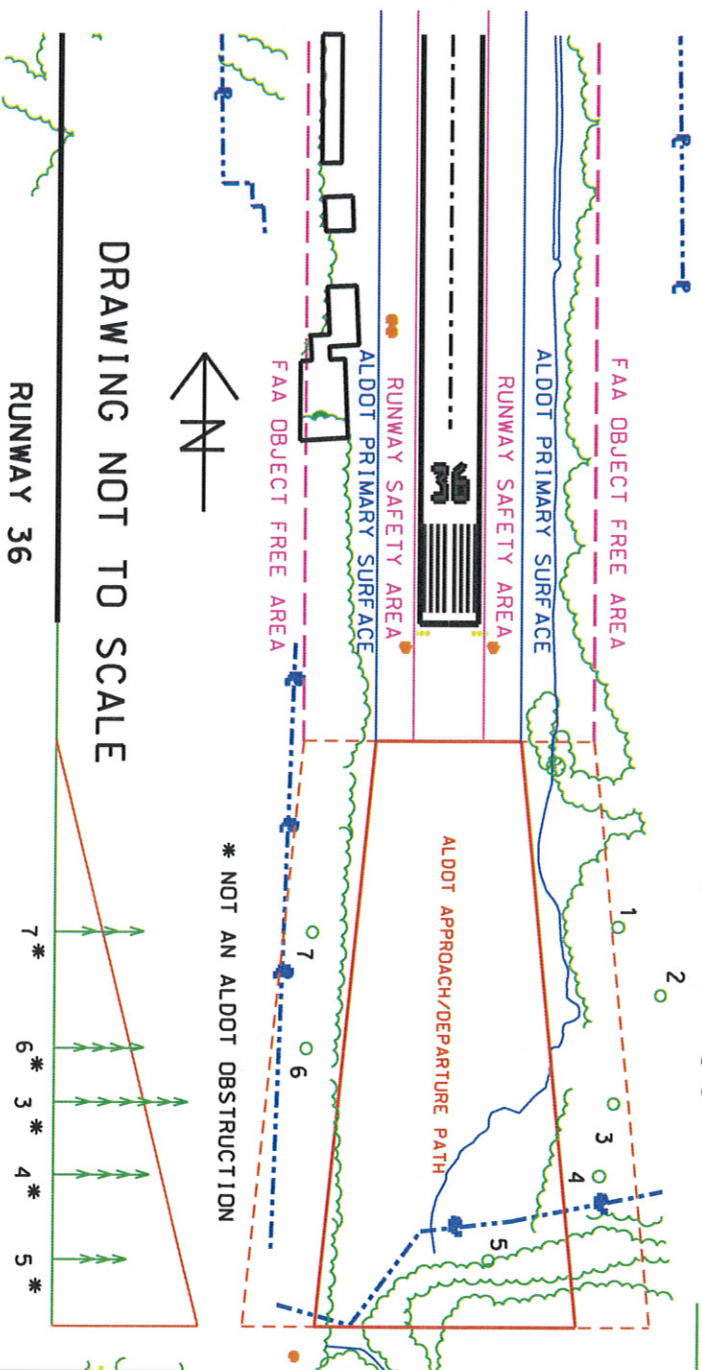
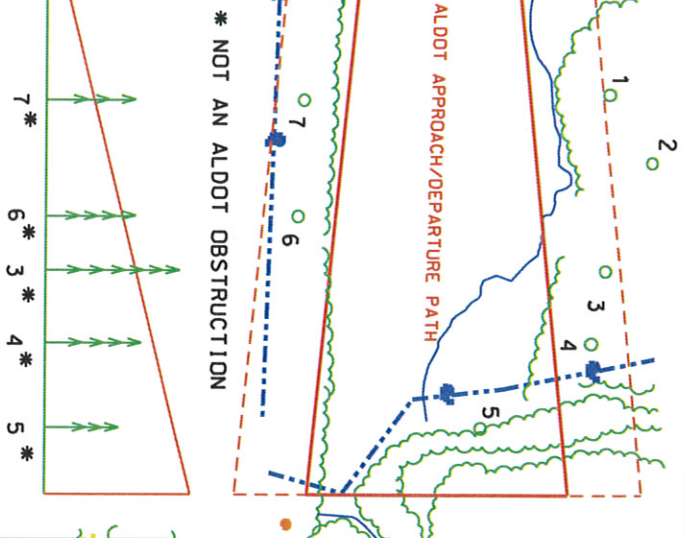
REQUIREMENTS FOR STATE AIRPORT LICENSE RUNWAY 36

- * 3. TREE - 46' ABOVE RUNWAY END
867' FROM RUNWAY END
28' RIGHT OF CENTERLINE
14:1 OBSTRUCTION CLEARANCE SLOPE
- * 4. TREE - 32.7' ABOVE RUNWAY END
978' FROM RUNWAY END
264' RIGHT OF CENTERLINE
23:1 OBSTRUCTION CLEARANCE SLOPE
- * 5. TREE - 25' ABOVE RUNWAY END
1089' FROM RUNWAY END
74' RIGHT OF CENTERLINE
35:1 OBSTRUCTION CLEARANCE SLOPE
- * 6. TREE - 30.6' ABOVE RUNWAY END
765' FROM RUNWAY END
242' LEFT OF CENTERLINE
18:1 OBSTRUCTION CLEARANCE SLOPE
- * 7. TREE - 30' ABOVE RUNWAY END
576' FROM RUNWAY END
263' LEFT OF CENTERLINE
12:1 OBSTRUCTION CLEARANCE SLOPE

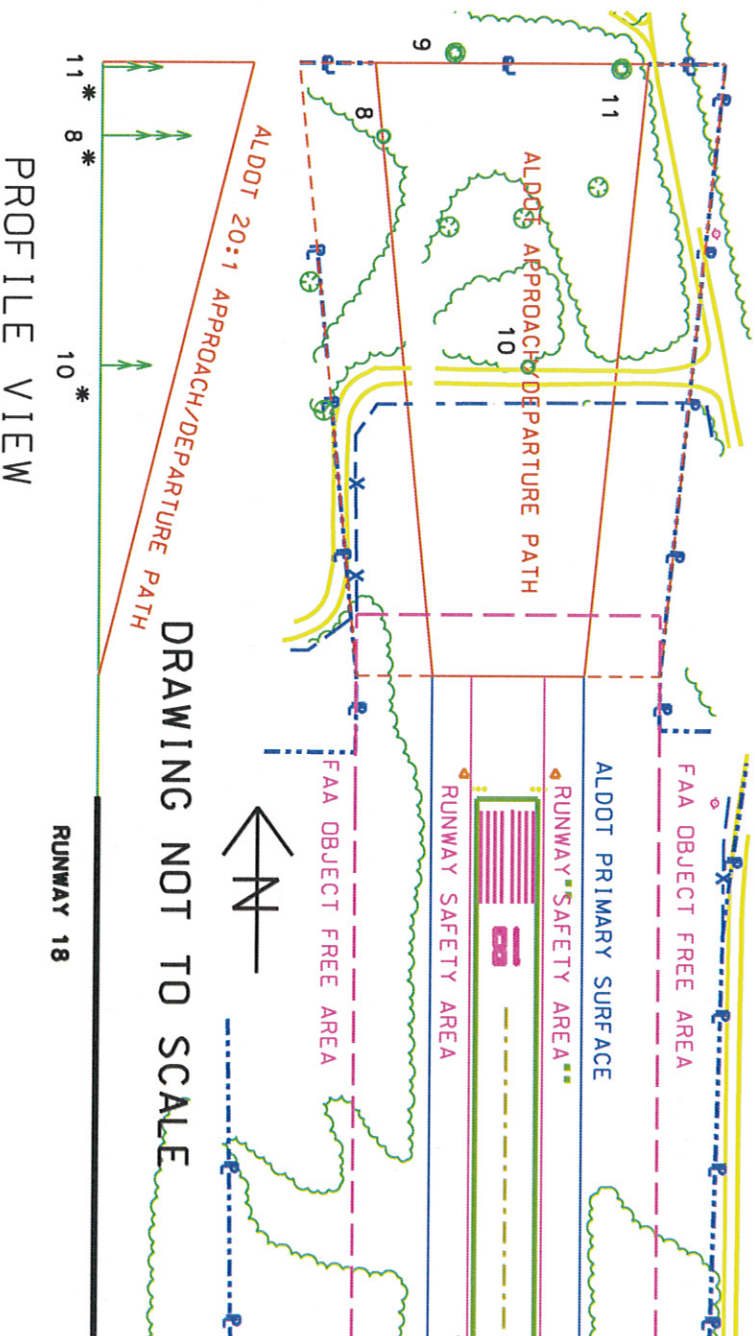
REQUIREMENTS FOR STATE AIRPORT LICENSE RUNWAY 18

- * 8. TREE - 29' ABOVE RUNWAY END
1101' FROM RUNWAY END
2111 RIGHT OF CENTERLINE
34:1 OBSTRUCTION CLEARANCE SLOPE
 - * 10. TREE - 16.4' ABOVE RUNWAY END
705' FROM RUNWAY END
29' LEFT OF CENTERLINE
30:1 OBSTRUCTION CLEARANCE SLOPE
 - * 11. TREE - 19' ABOVE RUNWAY END
1206' FROM RUNWAY END
180' LEFT OF CENTERLINE
52:1 OBSTRUCTION CLEARANCE SLOPE
- * NOT AN ALDOT OBSTRUCTION
